CASE STUDY – TANK INTERNAL LINING

This case study summaries the history of the internal protective coatings within KGCM's Kaltails water storage tank, sited in the Borefields region of Kalgoorlie/Boulder, Western Australia.

The tank is of mild steel construction, has a capacity of 377 kilolitres, and is located approximately 11 km south west of the KCGM open pits.

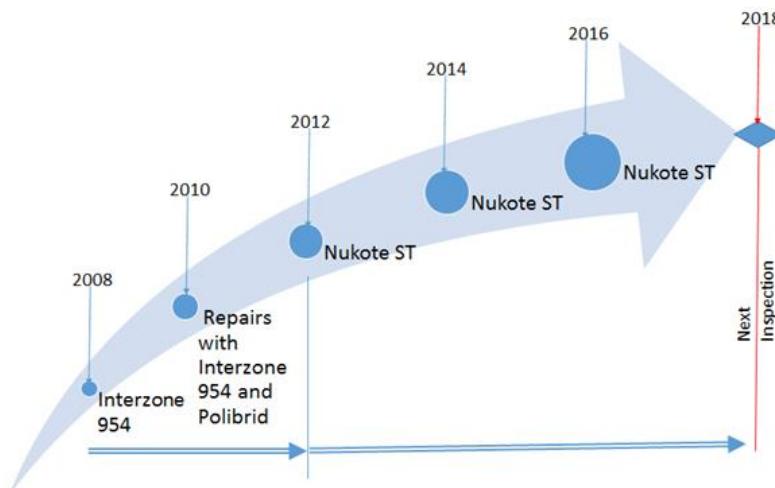
This tank's interior surfaces have undergone a number of coating specification changes and repairs as shown in Figure 1 below.

The initial coating systems specified and used on this tank, both on the interior and exterior are unknown. However, in 2008, the interior and the exterior were coated with Interzone 954. During an inspection in 2010, it was observed that the external surfaces had suffered minimal corrosion damage while the interior was exhibiting more significant damage due to defects in the coating and the hypersaline nature of the water. Repairs were carried using Interzone 954 and Polibrid-705E.

One of the recommendations from the 2010 Inspection Report was to fully line all internal surfaces with Nukote ST.

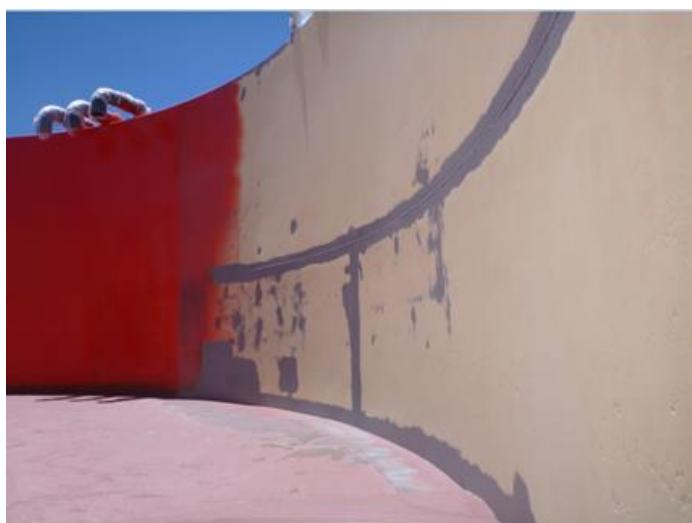
The previous internal lining repairs from 2010 (using Interzone 954 and Polibrid-705E) showed signs of deterioration. Most of the Polibrid patches were not adhered to the substrate and were able to be removed manually by hand and scraper.

Surface preparation on tank wall

All of the Polibrid-705E patch repairs were removed and the wall and base were abrasive blasted. Defective coating, corroded areas, corners and weld joints were abrasive blasted back to bare steel. Sound existing Interzone 954 was whip-blasted and not removed completely.

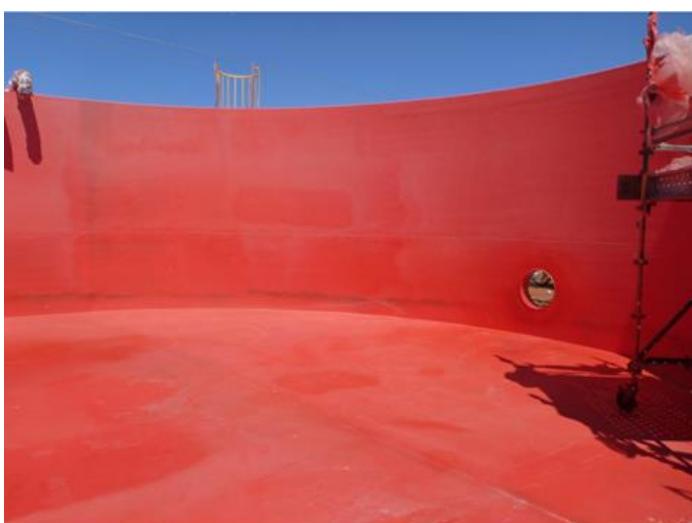
Completed Nukote ST Polyurea in 2012

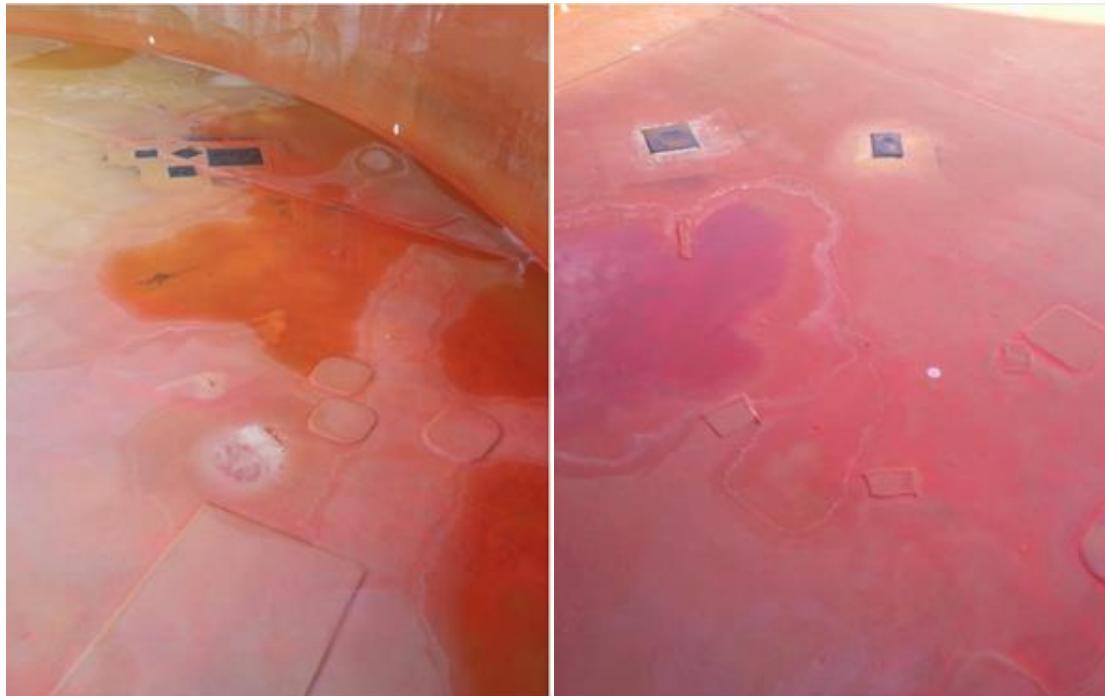
A number of localised blisters (each covering an area of less than 100 mm x 100 mm) were observed. Although these did not affect the integrity of the lining, they were removed and patched. Due to the rapid cure time of Nukote ST, the repairs could be completed at the time of the inspection, and without delaying returning the tank to service.

Patch repairs on floor in 2014

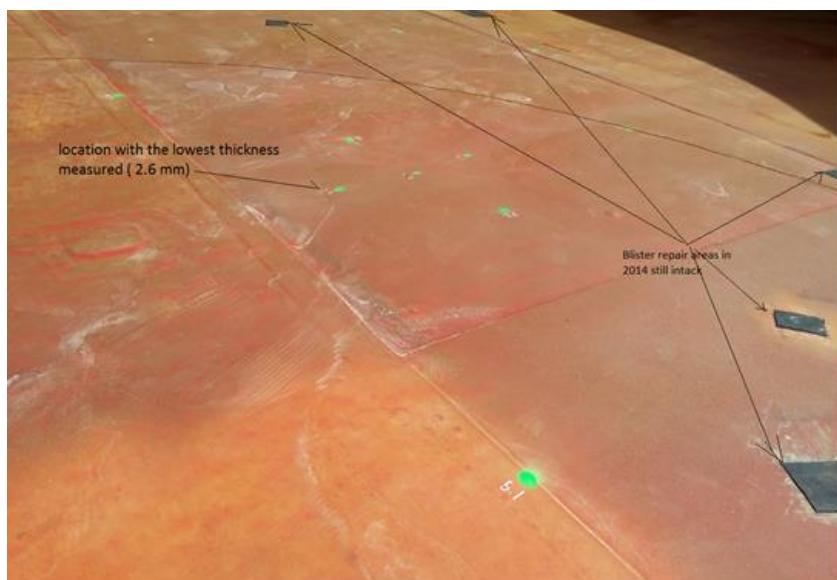
In July 2016, another inspection was undertaken by Nukote Australia. No blisters or damage to the interior lining were observed. The blistered areas that were repaired in 2014 were still intact and in good condition.

Tank floor conditions in 2016

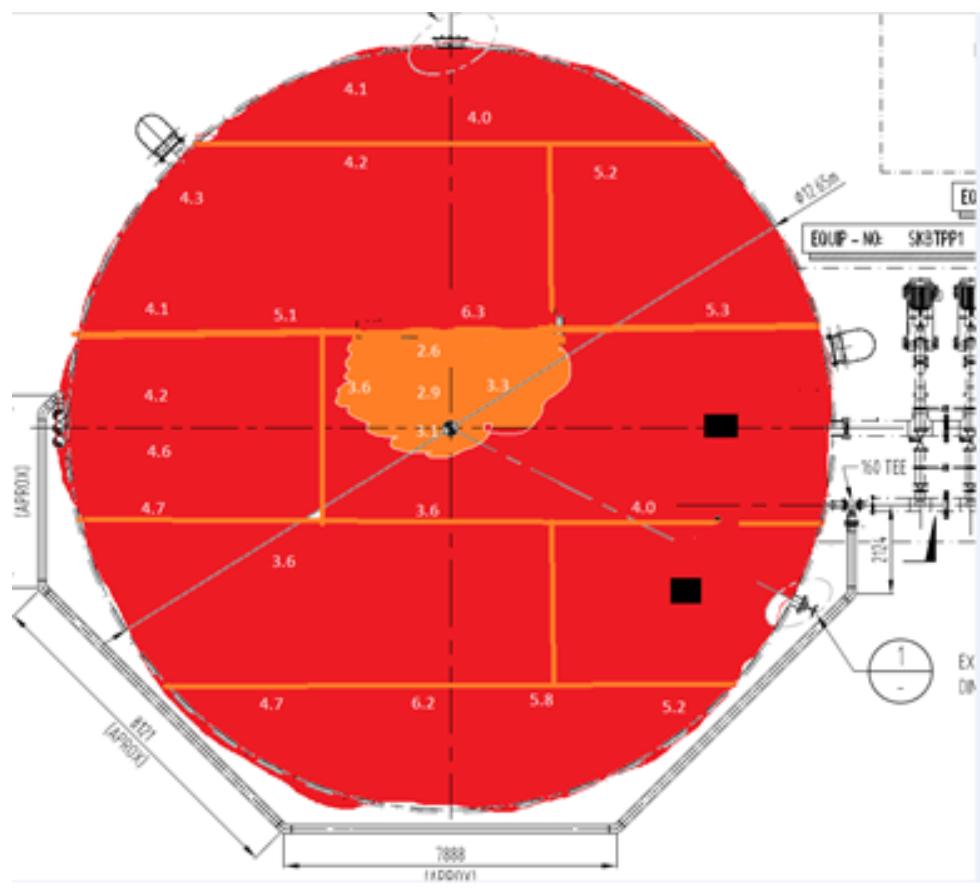
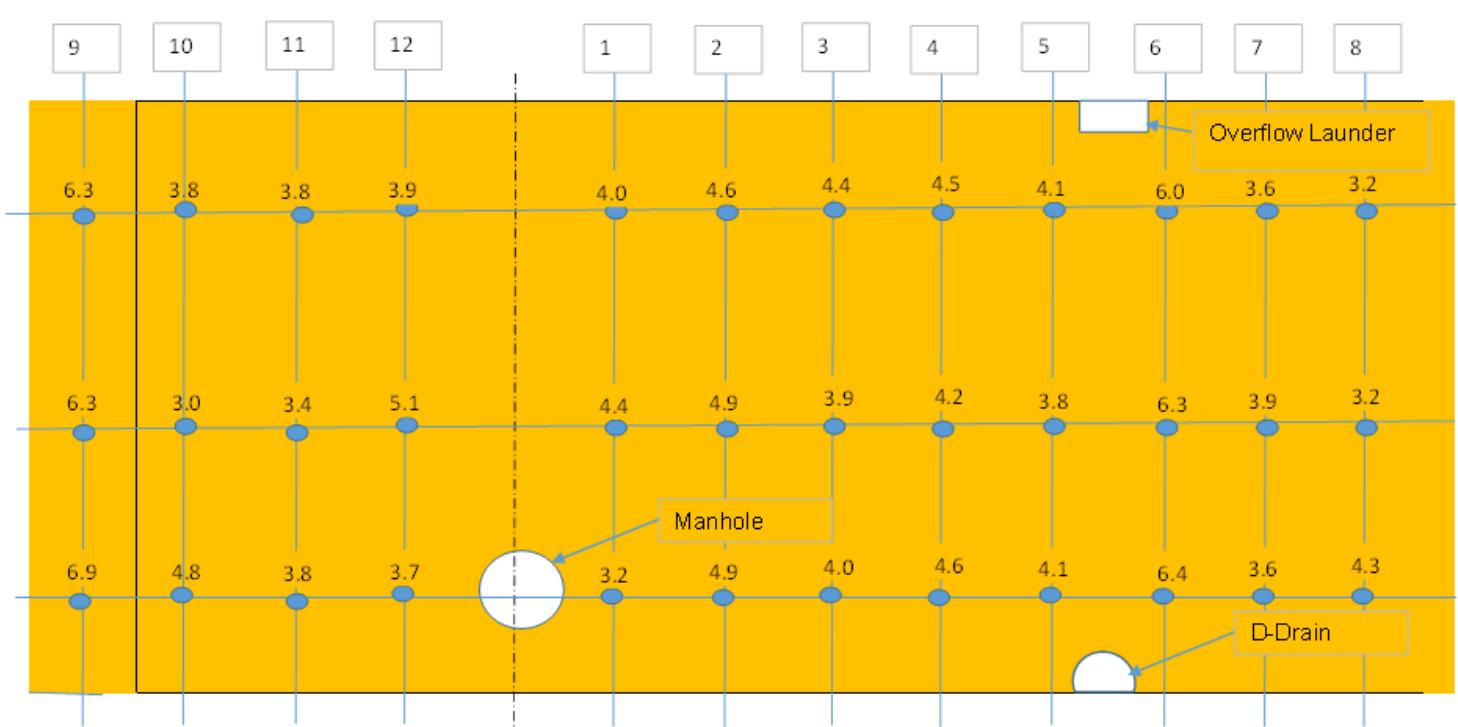
Thickness testing was performed on all internal areas (floor and wall) using calibrated Positector 6000 thickness gauge and the results are shown in the images below.

The tank interior lining (Nukote ST Pure Polyurea) was in excellent condition and there were no integrity concerns. There was no evidence of blistering or mechanical damage. The lowest thickness recorded, in an isolated area on the tank floor was 2.6mm and no coating or lining repairs were required. As such, it was recommended that another inspection be undertaken after 2 years.

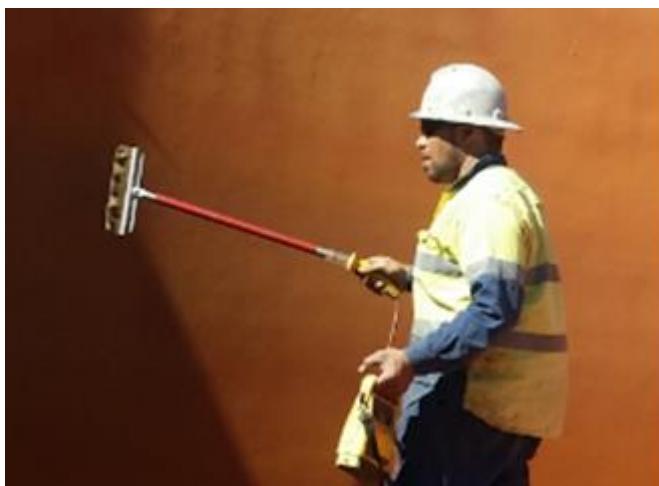
Holiday (spark) testing, using a High Voltage Holiday Tester, was carried out on all internal surfaces to ensure the continuity of the tank internal lining. There were no defects (i.e. pin holes or cracks) detected on the internal lining.

Holiday Testing

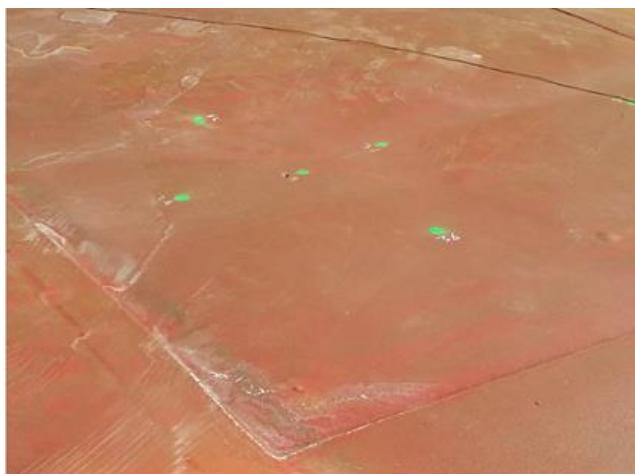
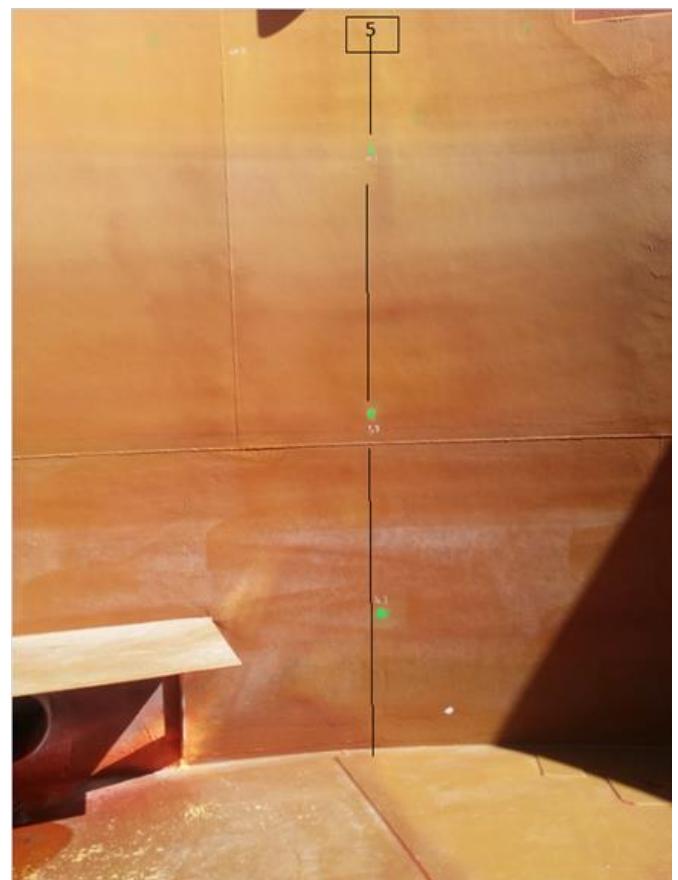
Tank internal lining conditions in 2016
