WATERPROOFING OF HUMID ROOMS (BATHROOMS, KITCHENS ETC)

THE PROBLEM

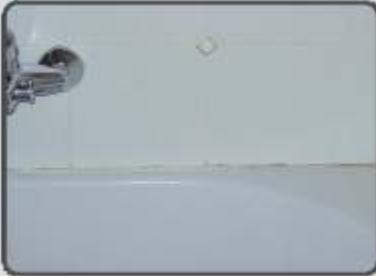
The sealant has been damaged due to moisture and mildew has started to grow.

The old sealant is removed mechanically (by chisel etc), trying not to damage the sanitary ware. Then the surface is cleaned with alcohol.

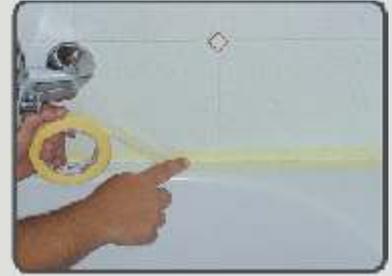
It is necessary to use adhesive tape in order to avoid dirt during application.

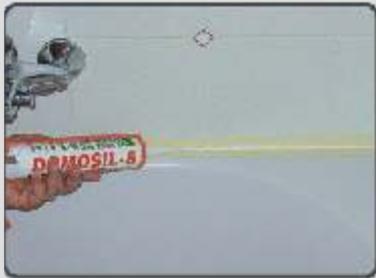
The intersection is sealed with the mildew-resistant silicone sealant **DOMOSIL-S**.

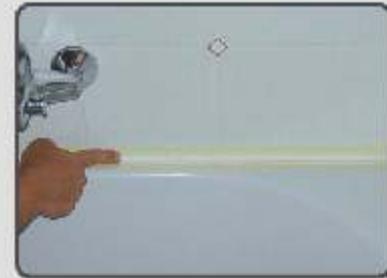
The sealant is formed while it is still fresh.

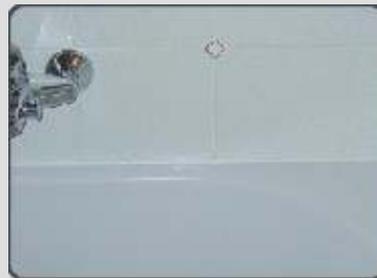
DOMOSIL-S seals and waterproofs the joint and helps to prevent mildew growth.

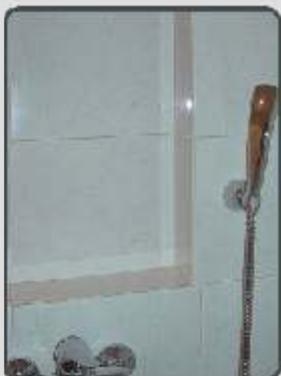
Moisture problems to rooms adjacent to bathrooms or kitchens appear because the tile grouts are absorptive.

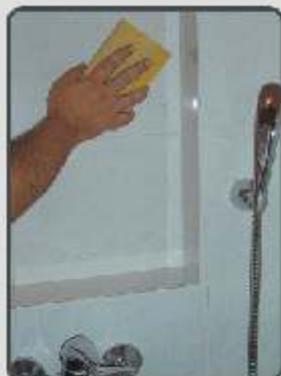
The tiles are cleaned by using a wet sponge.

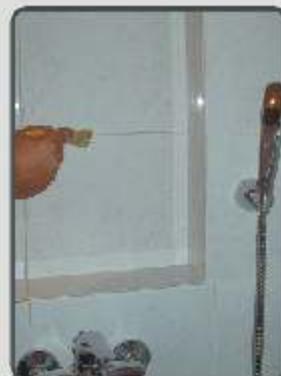
PS-21 is applied with brush along the joints in two layers.

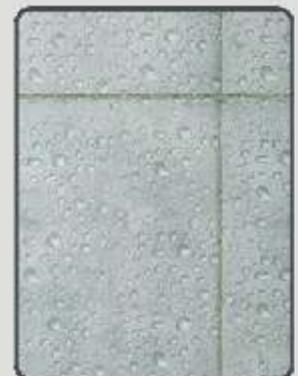
PS-21 penetrates the tile grout and waterproofs it without changing its appearance.
