Industry:
IRON ORE MINING

Project:
CONVEYOR BELT REPAIR

Application Type:
ABRASION

System:
NUKOTE HAR

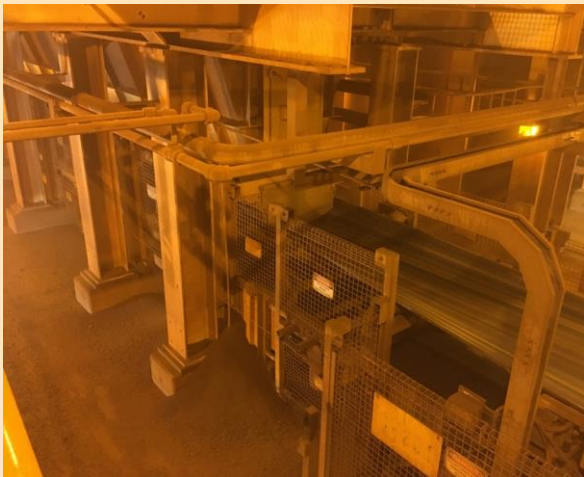
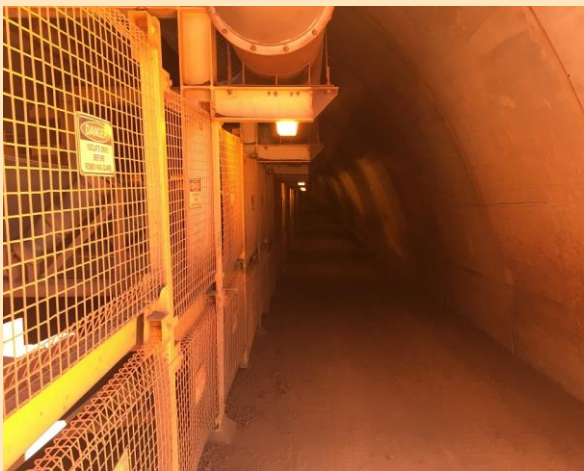
The belt surface had some damage / gauges on the sides due to abrasion from the product and skirting lines.

The repair process below was completed within 24 hour shutdown:

- The belt was whip blasted to clean the surface.
- Premera AE T7, a nano-adhesive primer, was applied to create molecular bridge between the polyurea coating and belt surface (rubber).
- Nukote HAR was applied straight after at 4 – 5 mm thickness on 300 mm wide on both sides of the belt.

The conveyor belt was back on operational 12 hours after coating application.
