## Project Profile

### AOFP (Algeria Oman Fertilizer Plant)

<b>INDUSTRY</b>	<b>: Fertilizer-Chemical Processing</b>
<b>CLIENT</b>	<b>: Mitsubishi Heavy Industries : Algeria-Oman Fertilizer Plant</b>
<b>CONTRACTOR</b>	<b>: Daewoo Engineering &amp; Construction</b>
<b>SUPPLIER</b>	<b>: Nukote Coating Systems International</b>
<b>APPLICATOR</b>	<b>: Nukote Coating Systems Singapore</b>
<b>PROJECT</b>	<b>: Process Basins-Containment-Channels</b>
<b>LOCATION</b>	<b>: Oran, Algeria</b>
<b>SYSTEM</b>	<b>: Nukote XT Plus</b>
<b>APPLICATION TYPE: New Construction Concrete</b>	
<b>COATED AREA</b>	<b>: 4,000 m<sup>2</sup></b>
<b>COMPLETION</b>	<b>: April 2011</b>

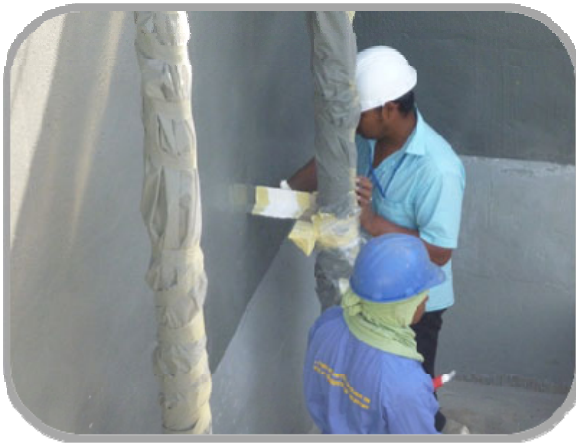
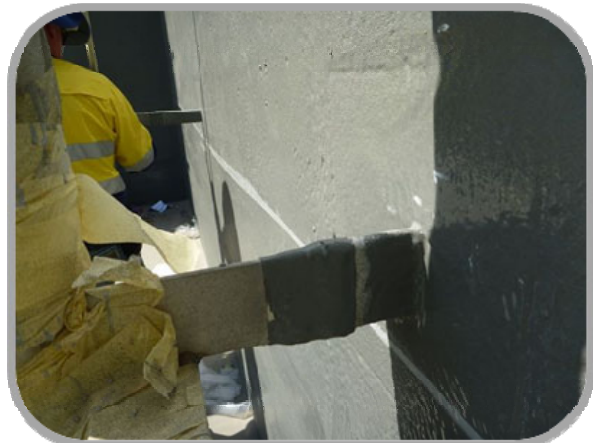
The largest application area was the chemical treatment and neutralization demi pits, which was completed in 10 working days. The concrete substrate required skim coating of voids using Nukote's epoxy / filler composite system to rid the substrate of defects.

All three pits were fitted with a series of brackets to support process pipe structures. This was recognised as a critical area for the application works. A site specific detail (pipe termination wrap) was designed and utilized to ensure that the coating was properly coating terminations at pipe brackets and other penetrations.

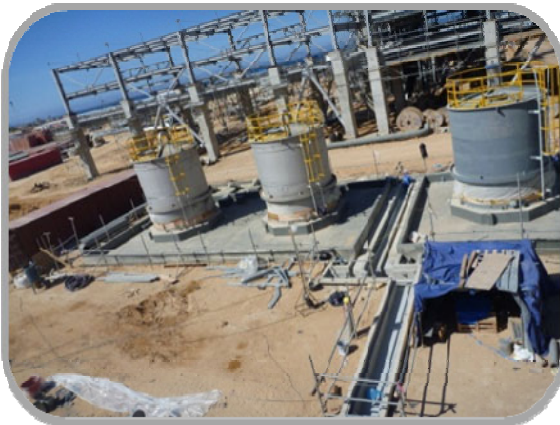
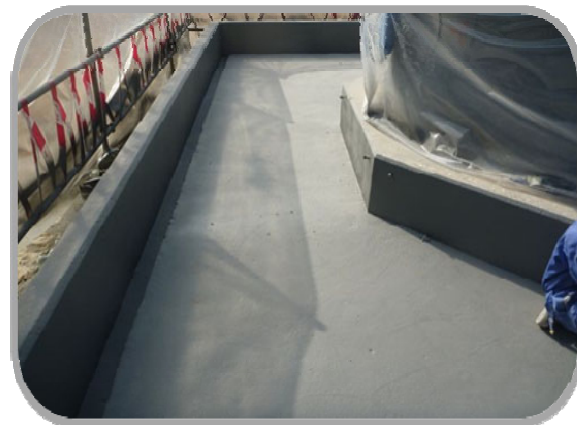
Two secondary containment bund areas were also coated, to ensure that Sulphuric Acid and Caustic Soda were properly contained should spills or leaks occur. This consisted of one bund area for caustic soda tanks and one bund area for sulphuric acid tanks.

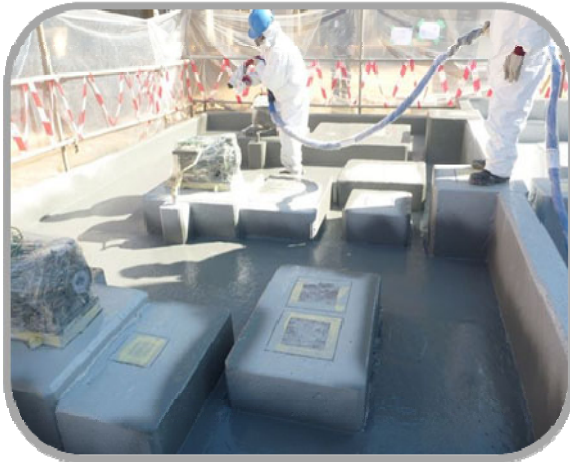
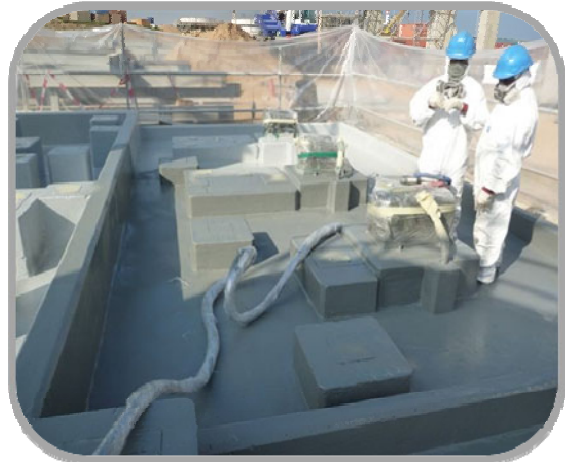
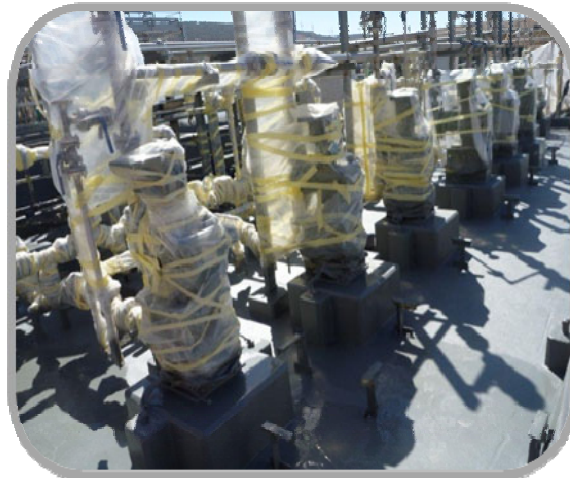
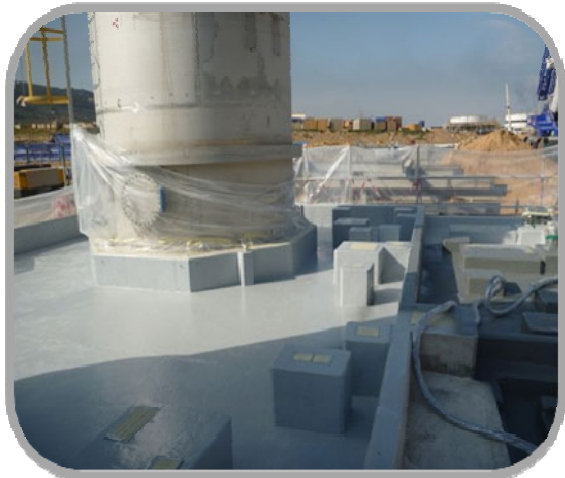
Three additional banded areas required protection with Nukote XT+. Two mechanical pump areas, one each for caustic and sulphuric liquid distribution, and one chemical dosing area where a variety of process chemicals are injected for treatment and neutralization in the plant aeration pits.

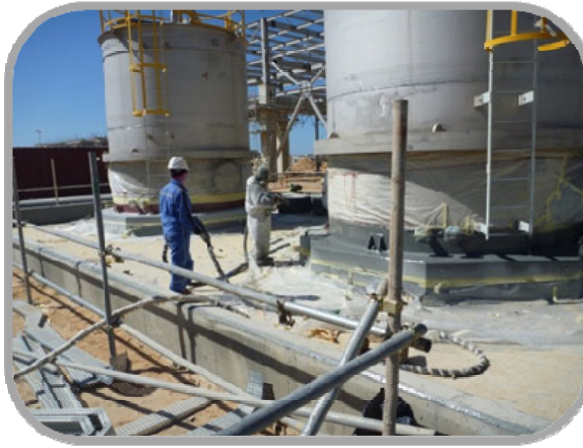
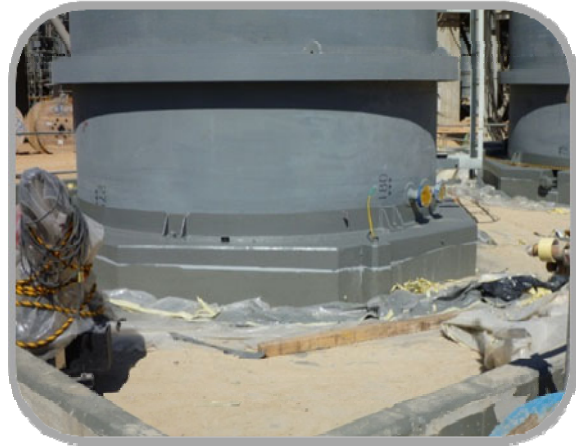
Ring beam protection, which is a common corrosion problem that occurs where a steel tank sits on a concrete base, was addressed with formal termination details submitted and approved by the Client.

Chemical attack and differential thermal expansion rates can cause failure of jointing systems allowing corrosive vapor or liquid to ingress under the tank. Corrosion can then progress rapidly, leading to perforation and leakage with the associated environmental damage, tank repairs costs and lost production.
