Project Profile

Trio at Atria, 50 Ann O'Reilly Rd. North York, ON M2J 0C9

- Storm Water Tank and Irrigation Tank
- Waterproofing & Protection
- Polyurea Membrane Coating – NUKOTE ST M
 - Duroprimer SG

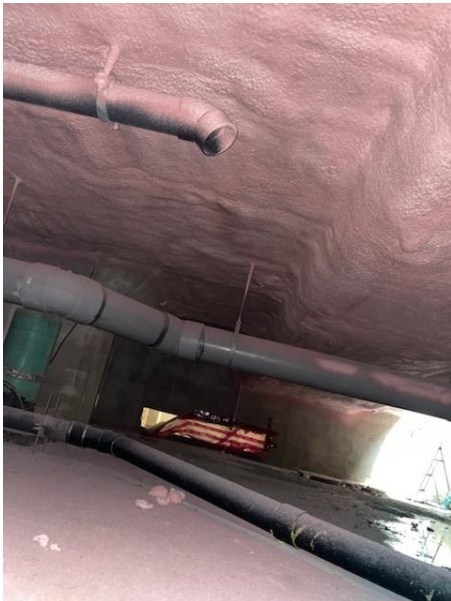
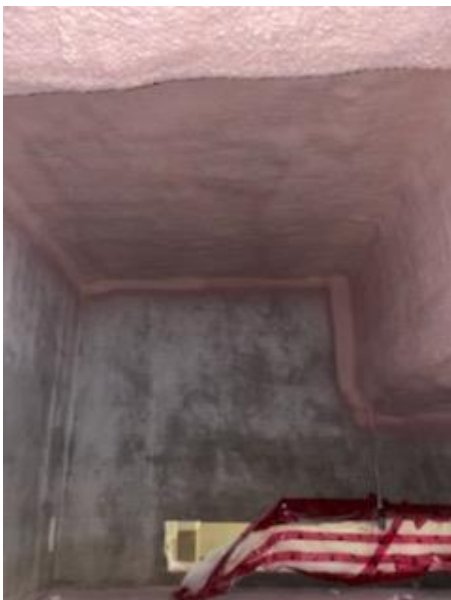
Polyurethane Foam Installed:

Supply and install a hot spray applied polyurea protective and waterproof coating to walls and floors of 6,666 sq.ft. storm water tank and 711 sq.ft. irrigation retention tank. Polyurethane spray foam insulation was applied to tank ceilings with polyurea to be sprayed over top.

- Concrete tanks were prepped and cleaned to ensure appropriate surface profile for coating adhesion.
- Pipe penetrations sealed with Flex PU 50 S polyurethane sealant.
- Polyurethane spray foam applied to ceiling via plural component spray system.
- Nukote ST M polyurea waterproof and protective membrane applied via plural component spray system.
