### **Project Profile**

#### TMG Plaza Midtown, 33 Holly St. Toronto, ON M4S 2G8

- Storm Water Tank Waterproofing & Protection
- Polyurea Membrane Coating NUKOTE ST
- Nukote EP Prime II

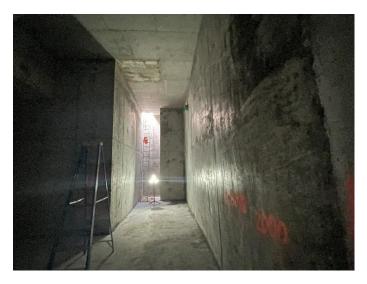
#### **PREPPED TANK:**

- Concrete tank was prepped and cleaned to ensure appropriate surface profile for coating adhesion.
- Tank was coated with the primer NUKOTE EP Prime II.
- Pipe penetration sealed with Flex PU 50 S polyurethane sealant.
- Nukote ST polyurea waterproof and protective membrane applied via plural component spray system.
